THE STANTON HOUSE

Historic Structure Report

Women's Rights National Historical Park
Seneca Falls, New York

Barbara A. (Pearson) Yocum
Building Conservation Branch, Northeast Cultural Resources Center
Northeast Region, National Park Service
U.S. Department of the Interior
Lowell, Massachusetts

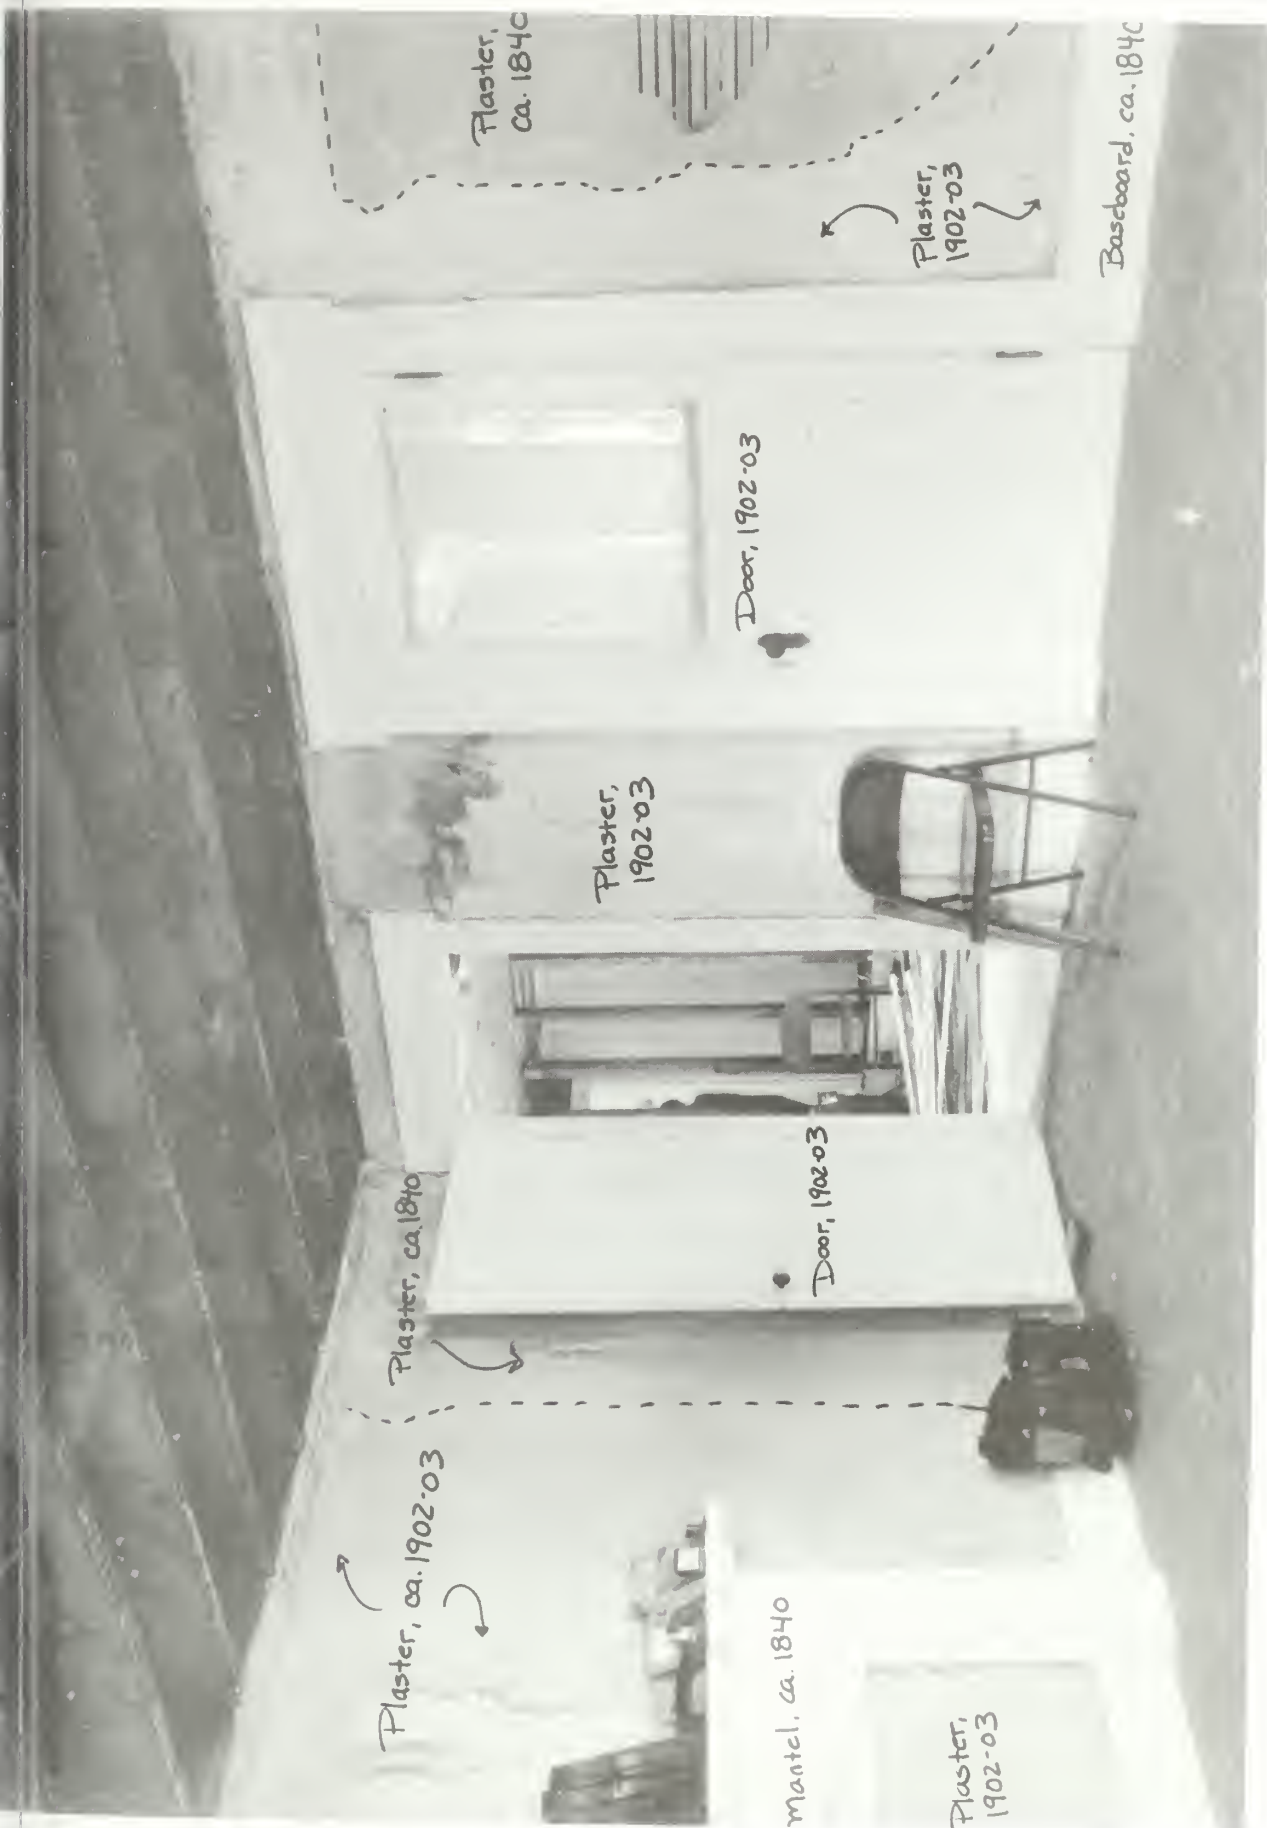
Figure 41. Stanton House: Room 101, looking southeast, July 1982.

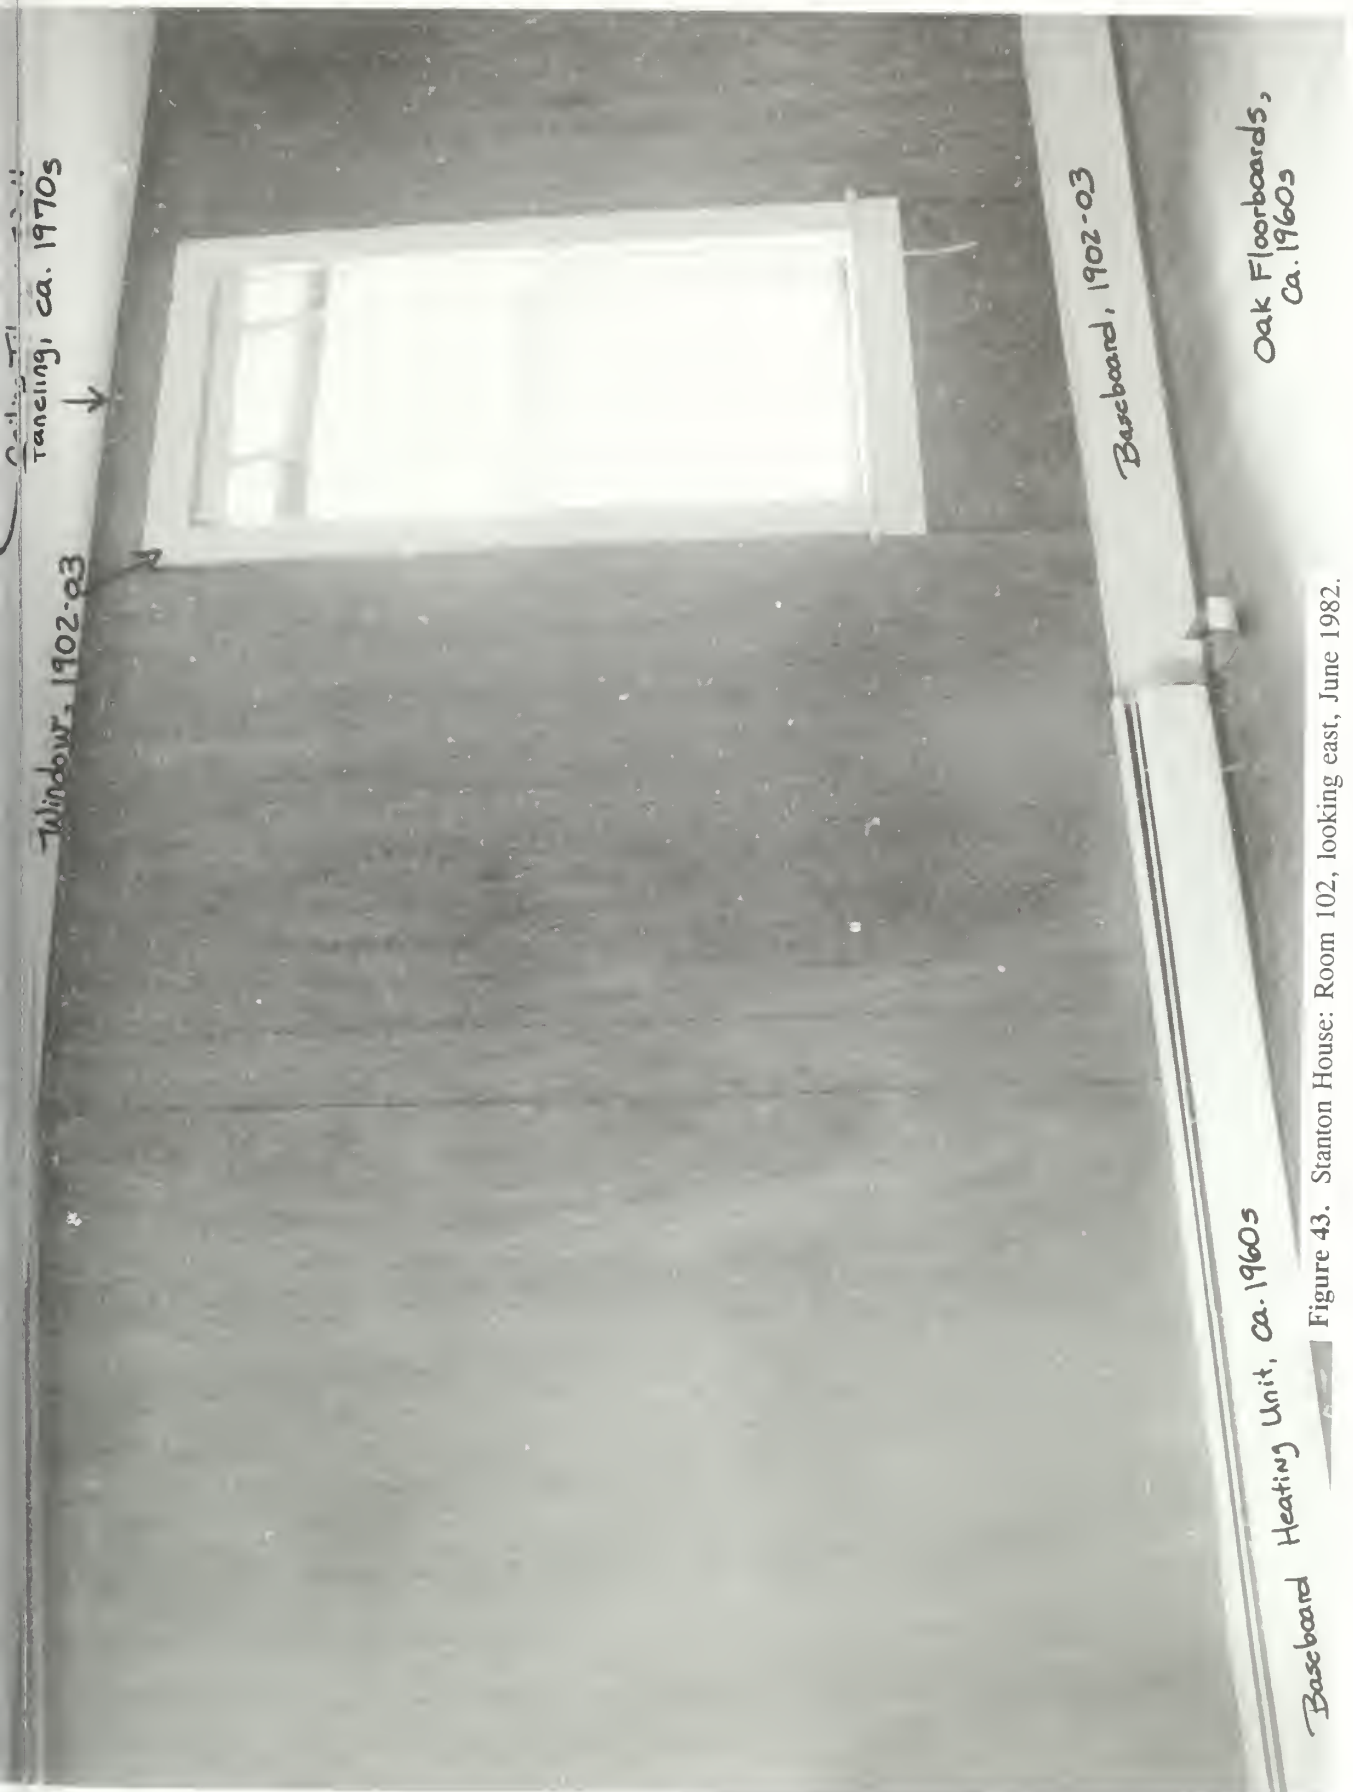
Figure 43. Stanton House: Room 102, looking east, June 1982.

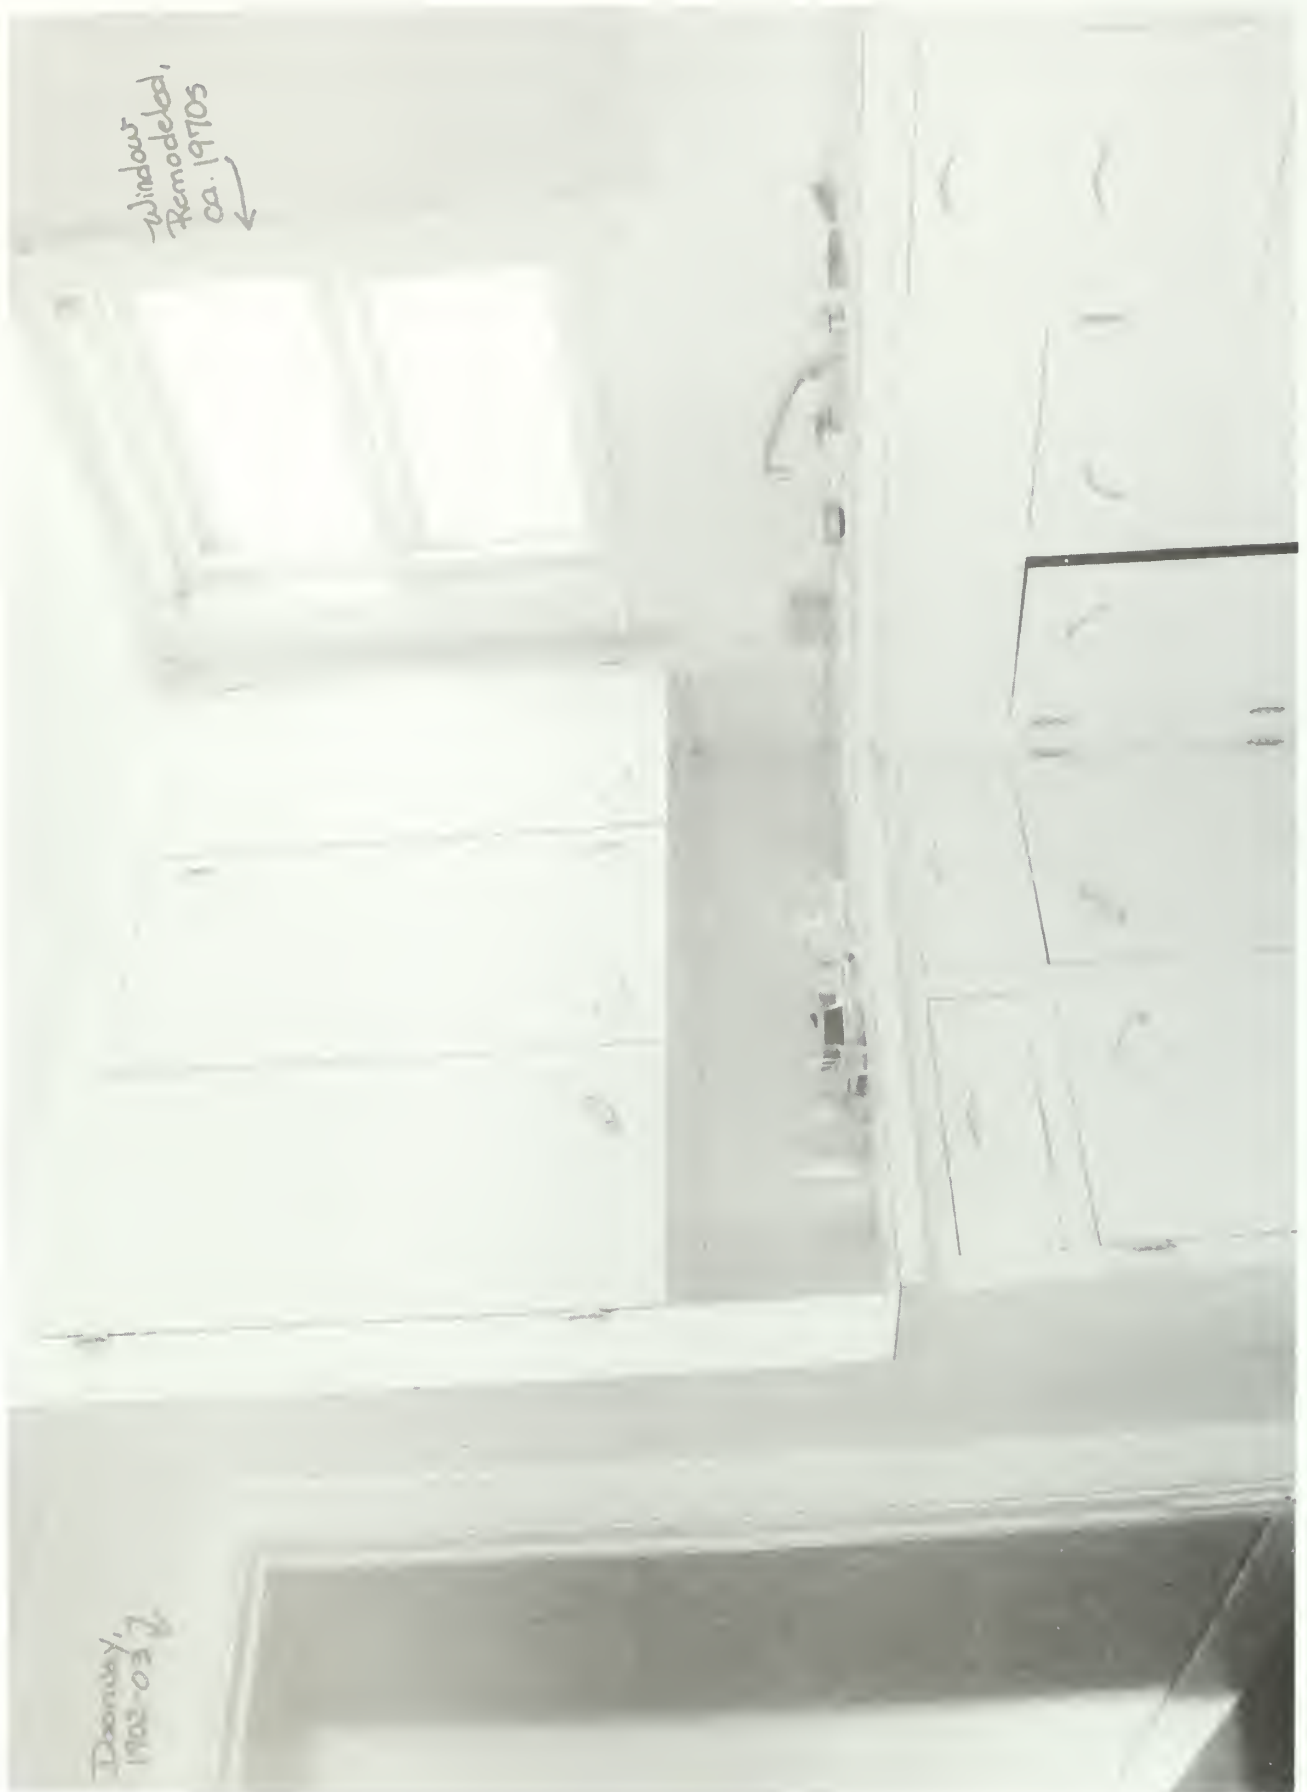
Figure 52. Stanton House: Room 105, looking northwest, June 1982.

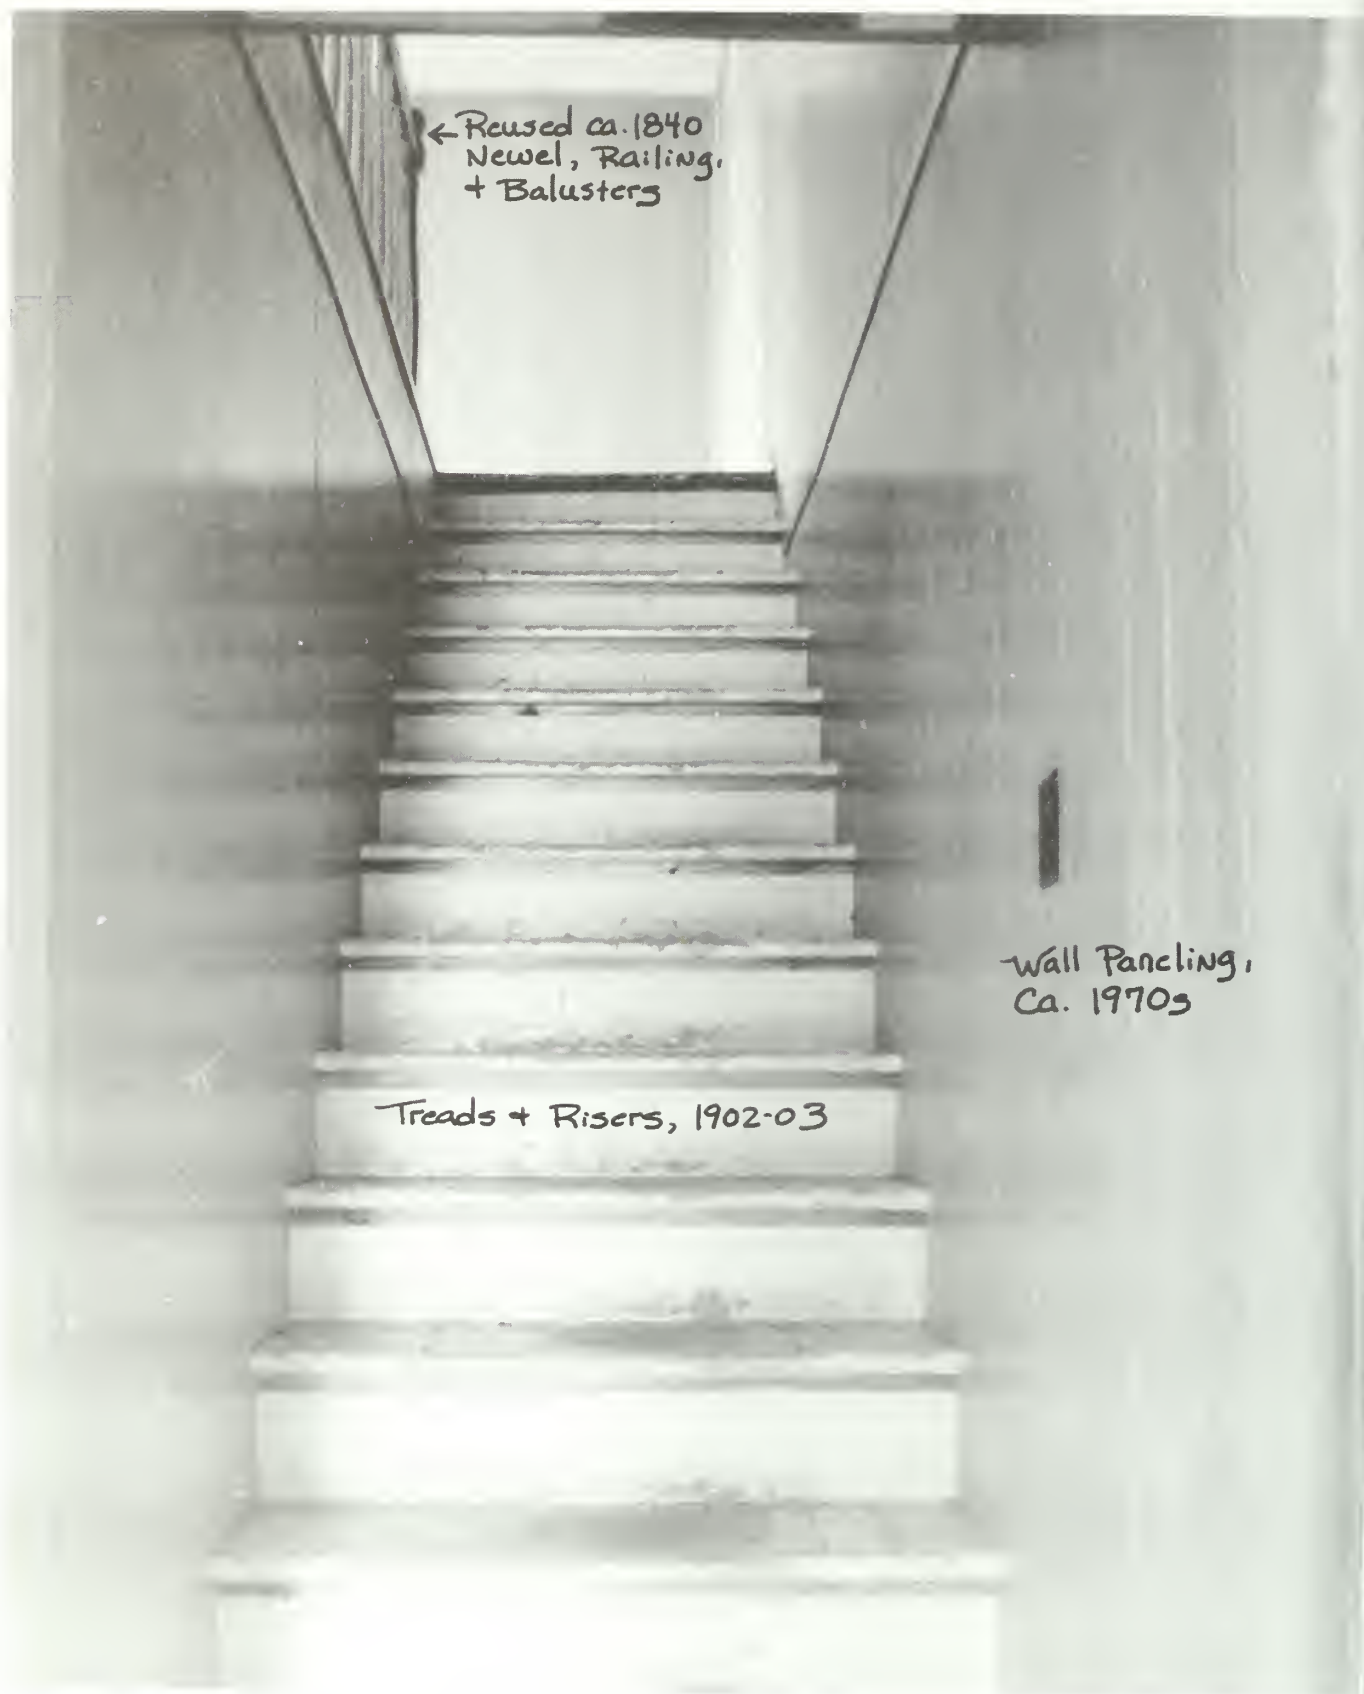
Figure 54. Stanton House: stairway to the second story.

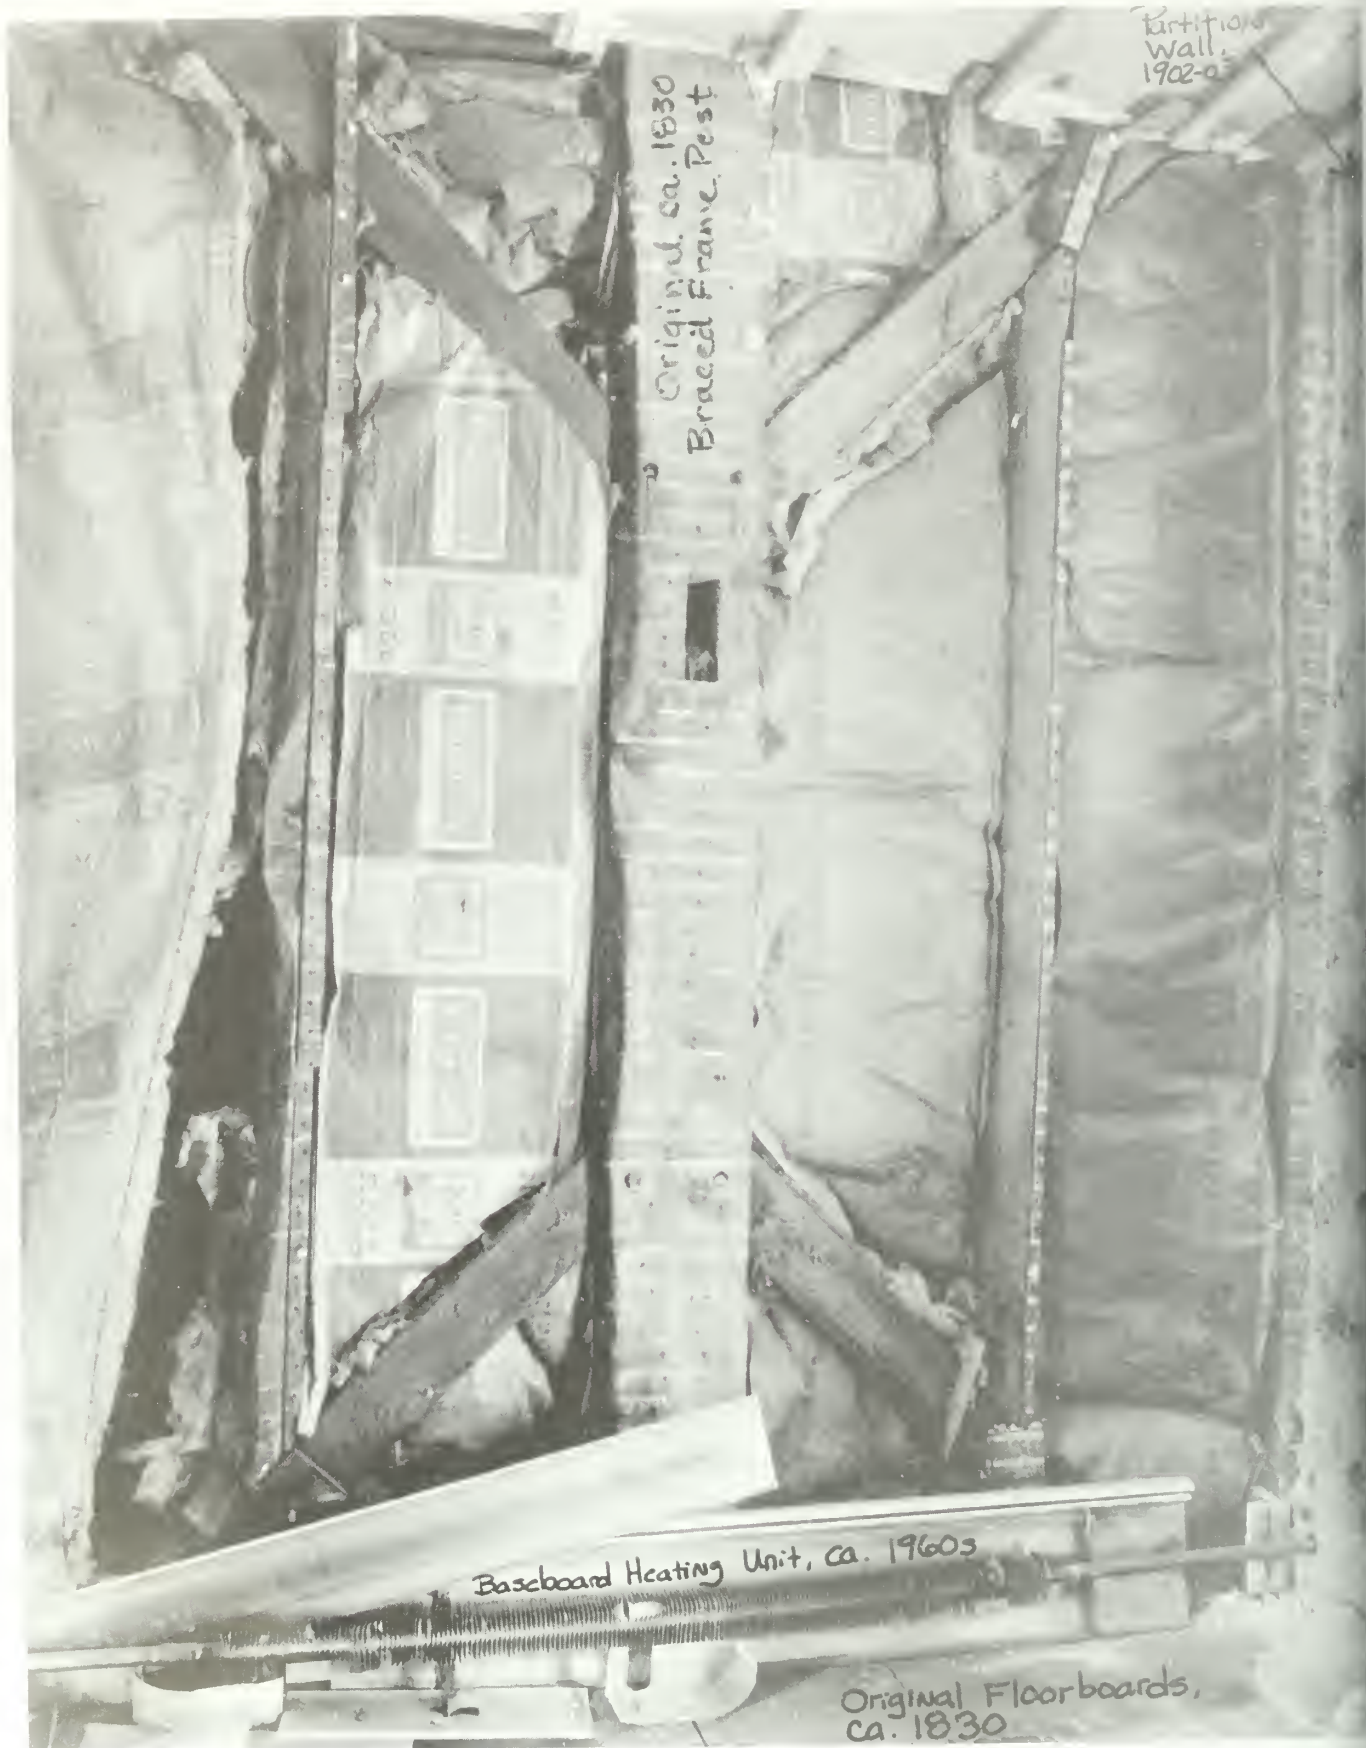
Figure 58. Stanton House: second-story hall, detail of braced-frame post at north wall, July 1982.

Stabilize the remaining post and beam frames of the historic main house and the south wing. New lumber should be installed where the old framing is missing, such as the knee braces and studs in the main house, the north end girt in the south wing, the east and west roof plates (cut for later windows) in the south wing, and the collar ties for the roof rafters in the south wing. Repair those portions of the frame that are in poor condition, using a combination of consolidation, reinforcement, and replacement. Framing members that are in good repair except for small areas of rot should be consolidated with a product such as "Seep 'N' Seal." One area where this treatment could be used is the northeast corner of the south wing's sill. All major connections in both the main house and the south wing need to be reinforced. One method that should be considered is the "Beta" system, which uses a combination of epoxy resin to consolidate the wood and fiberglass rods to impart structural stability. The advantage of this approach is that it preserves original framing members. Unfortunately, some of the framing members are very badly deteriorated and will probably have to be replaced with new wood. These areas include the northeast and southwest corner posts of the main house, the southeast and southwest corner posts of the south wing, and the south wall of the south wing. Structural reinforcing using wood or steel is also advised for the following areas: the second-story joists of the main house, the middle beam in the first story of the south wing, and the middle beam in the second story of the south wing. Structural reconstruction is suggested for one area only: the missing west porch, for which adequate photographic documentation exists.

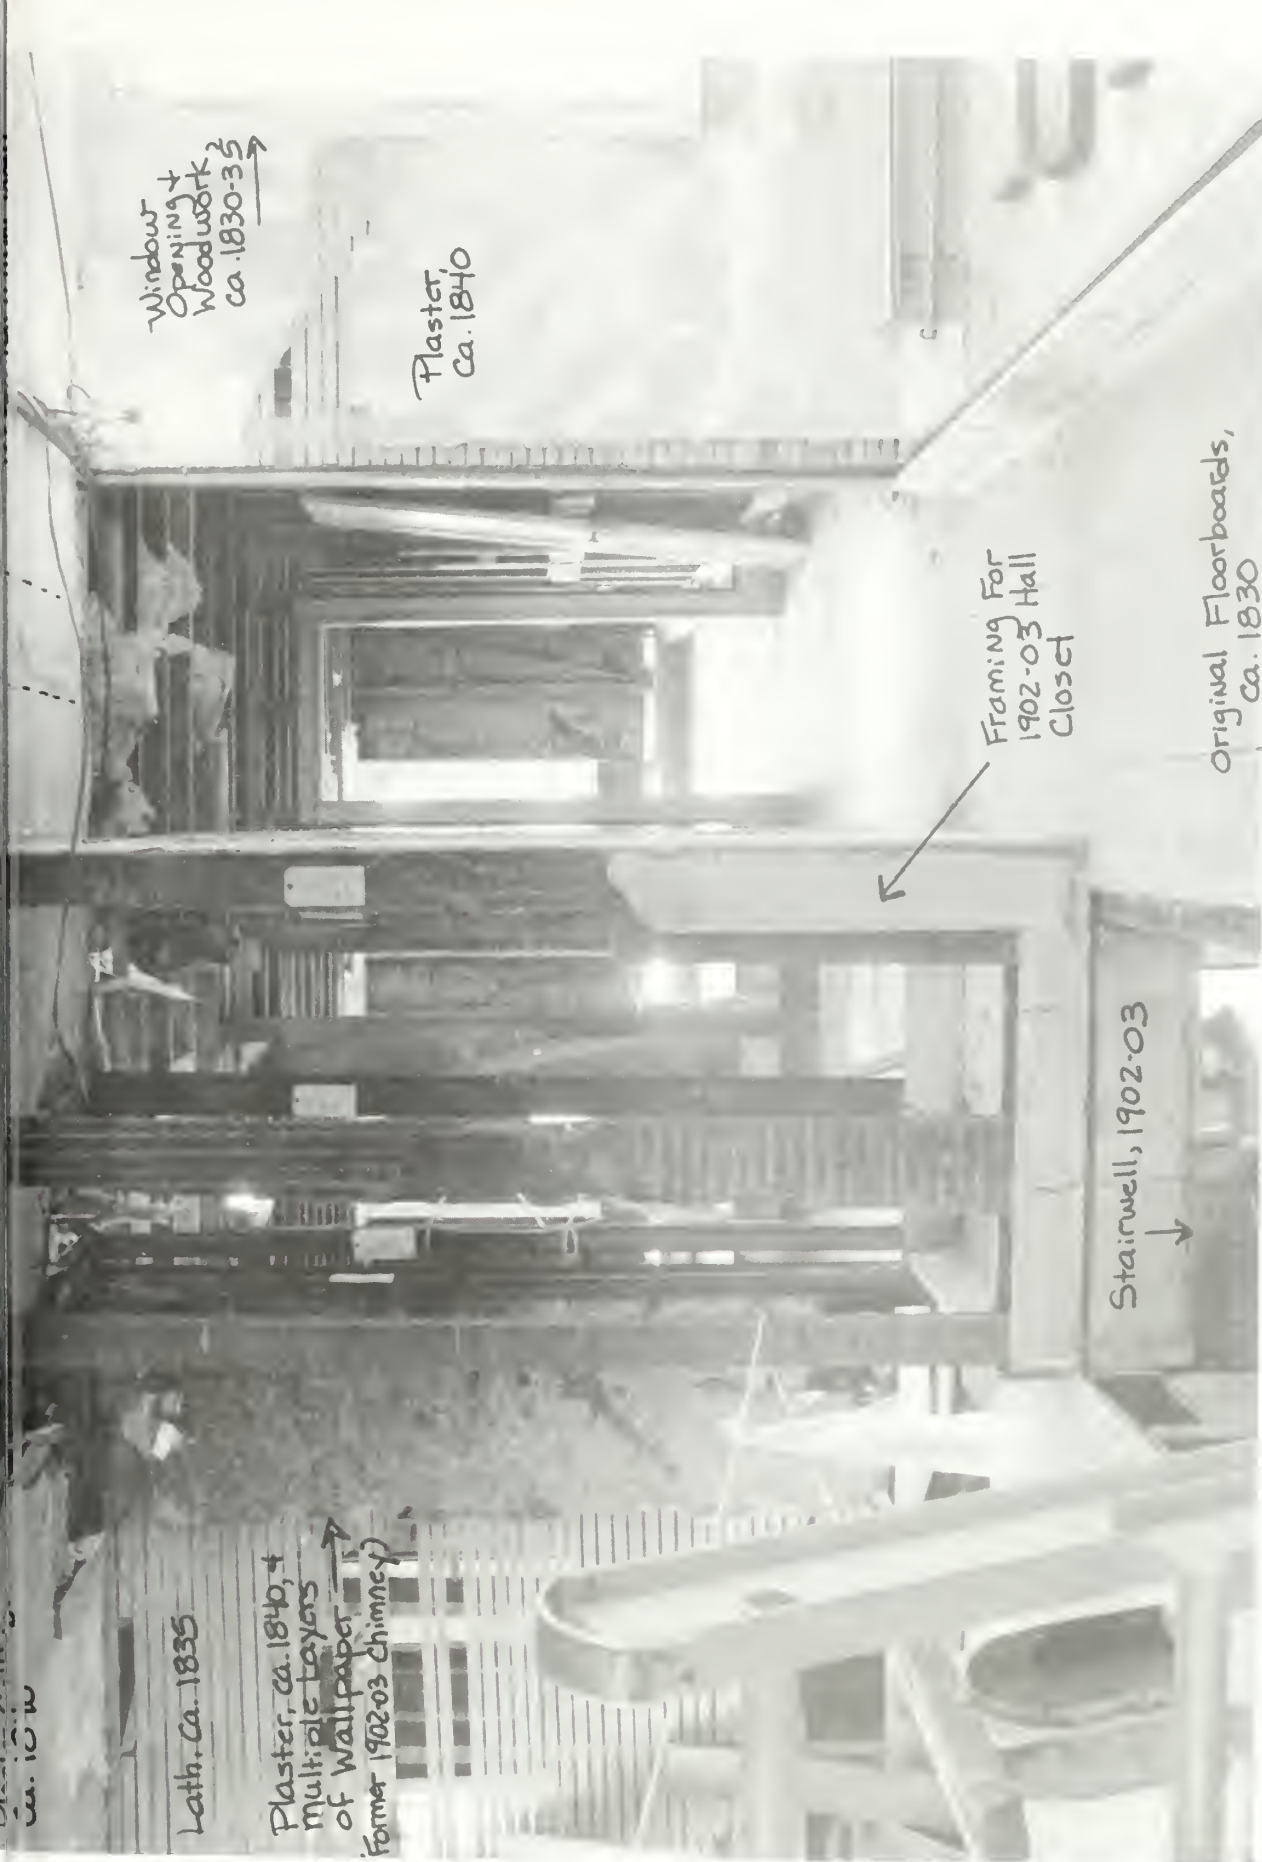
Figure 59. Stanton House: second-story hall, looking south, October 1982.
